## **Preliminary Tree Survey and Arboricultural Impact Assessment – Rehoboth College, Maddington**

**JUNE 2026**

**Date inspected:** 29<sup>th</sup> of June to 30<sup>th</sup> of June 2026  
**Location:** Rehoboth College, Maddington  
corner Maddington Road and Alcock Street

**Prepared For:** Rehoboth Christian College

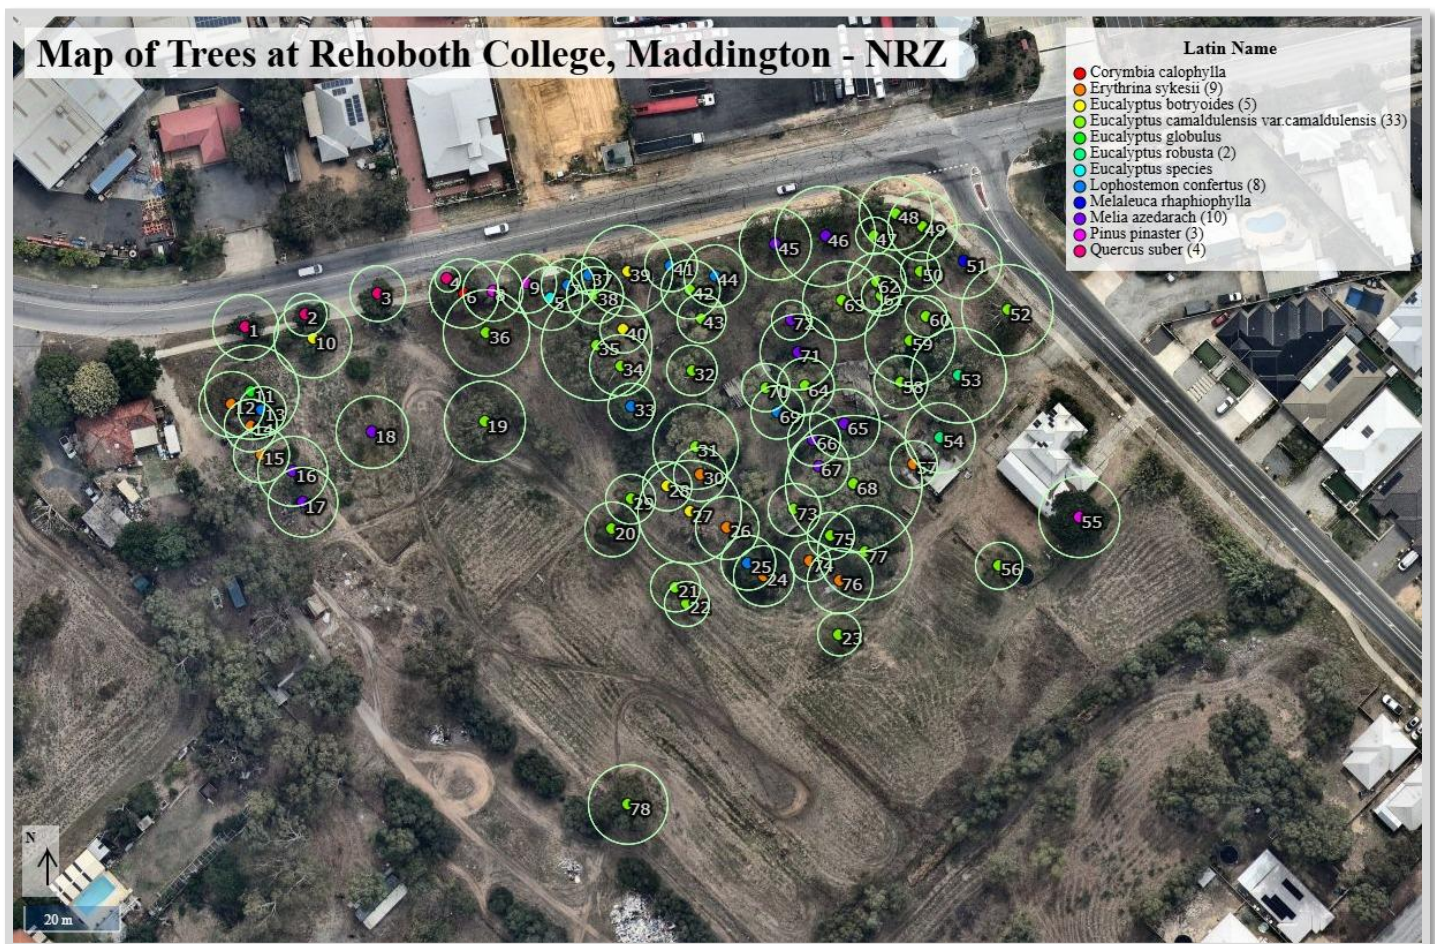
Figure 1: The overall map displays the Notional Root Zone (NRZ) radius overlays and location of all 78 trees.

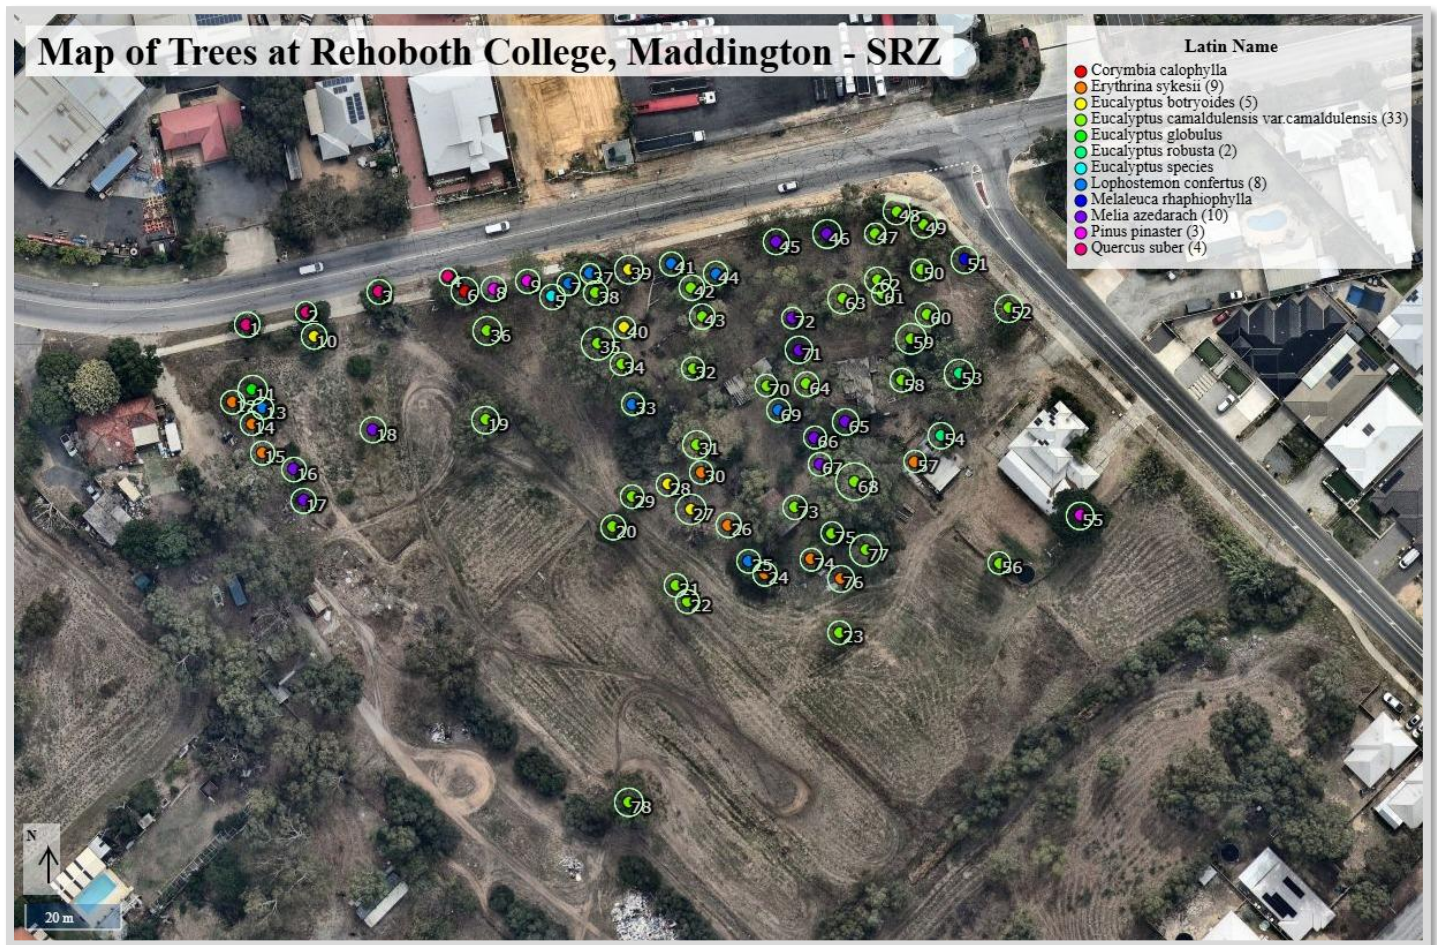
Figure 2: The overall map displays the Structural Root Zone (SRZ) radius overlays and location of all 78 trees.

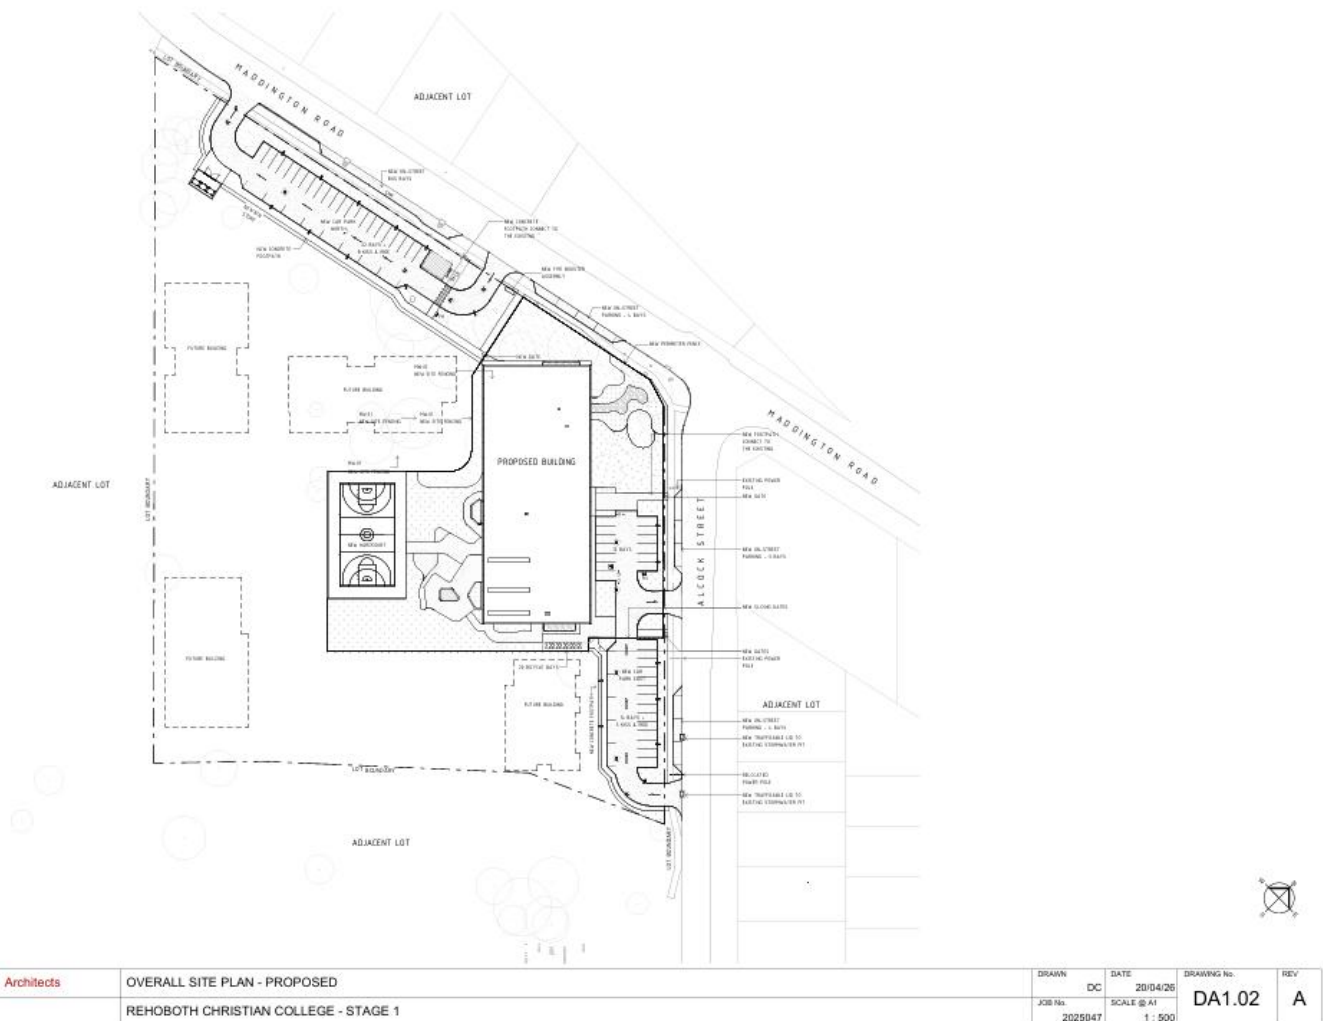
Figure 3 Displays the Rehoboth College Maddington proposed site plan.

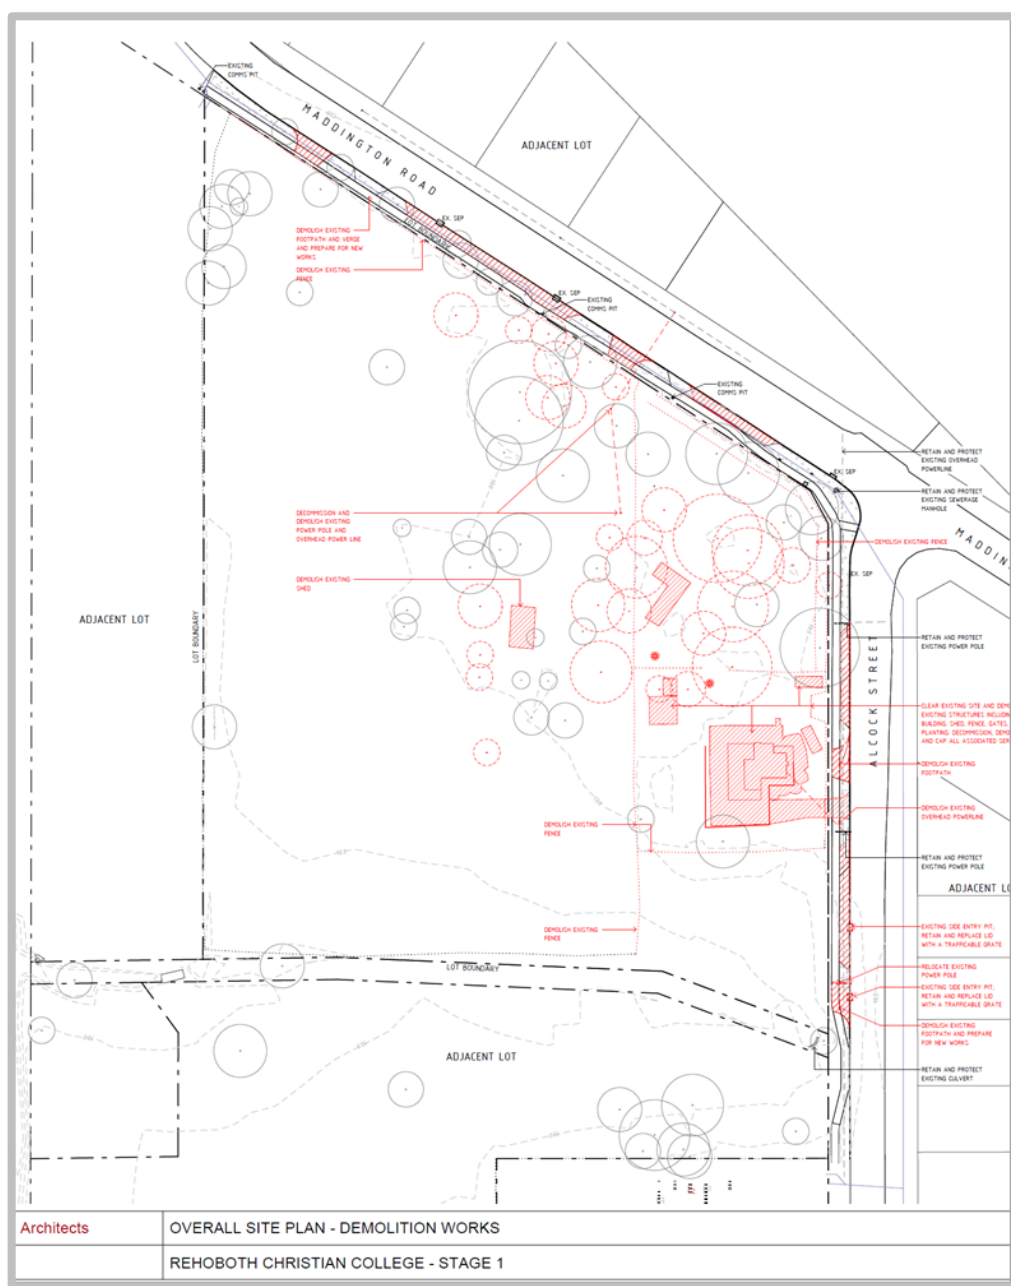
Figure 4 Displays the demolition overlay.
