## **Preliminary Tree Survey and Arboricultural Impact Assessment – Rehoboth College, Maddington**

**JUNE 2026**

**Date inspected:** 29<sup>th</sup> of June to 30<sup>th</sup> of June 2026  
**Location:** Rehoboth College, Maddington  
corner Maddington Road and Alcock Street

**Prepared For:** Rehoboth Christian College

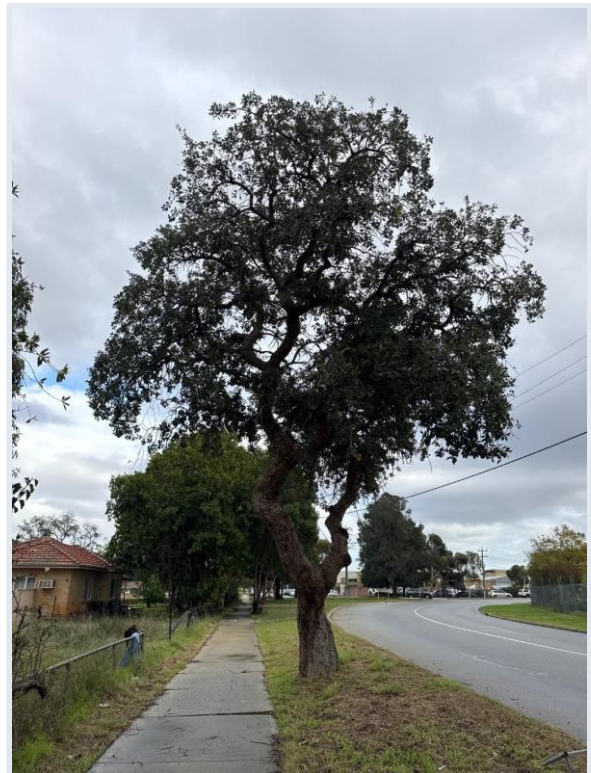
Retention Value: High

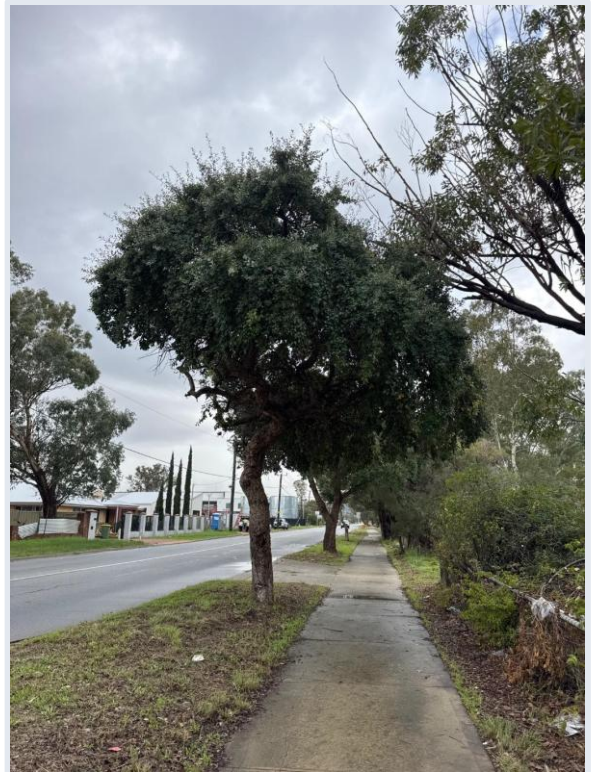
## Cork Oak Tree ID #2

| Retention Value: | High |

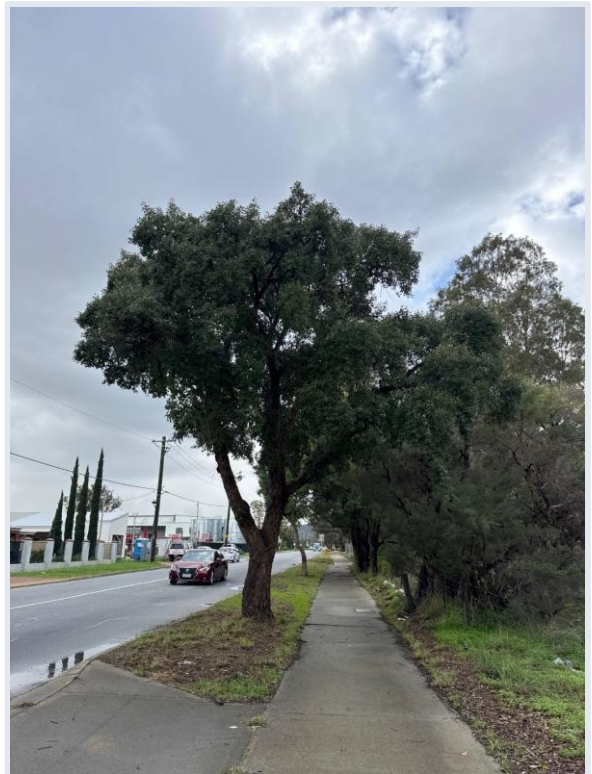
## Cork Oak Tree ID #3

| Retention Value: | High |

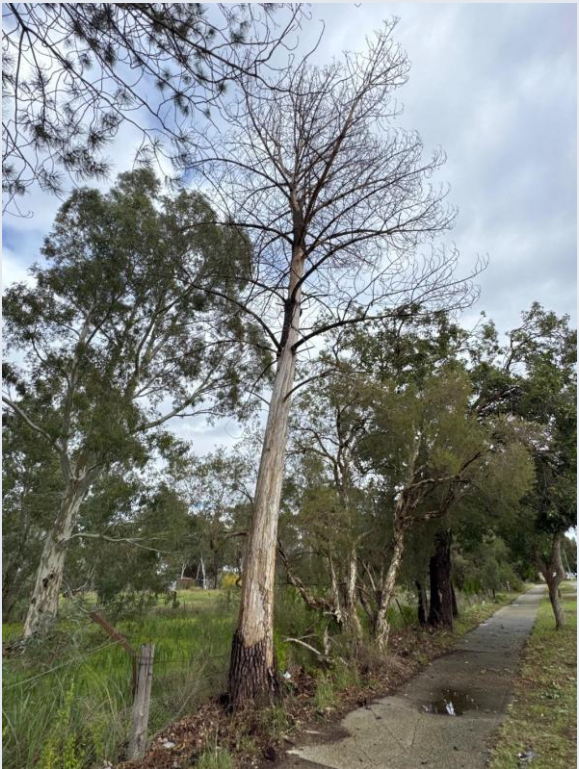
| Maritime Pine Tree ID #8 | |

| Maritime Pine Tree ID #8 | |
|---|---|
| Useful Life Expectancy: | 0 years |
| Retention Value: | Low |

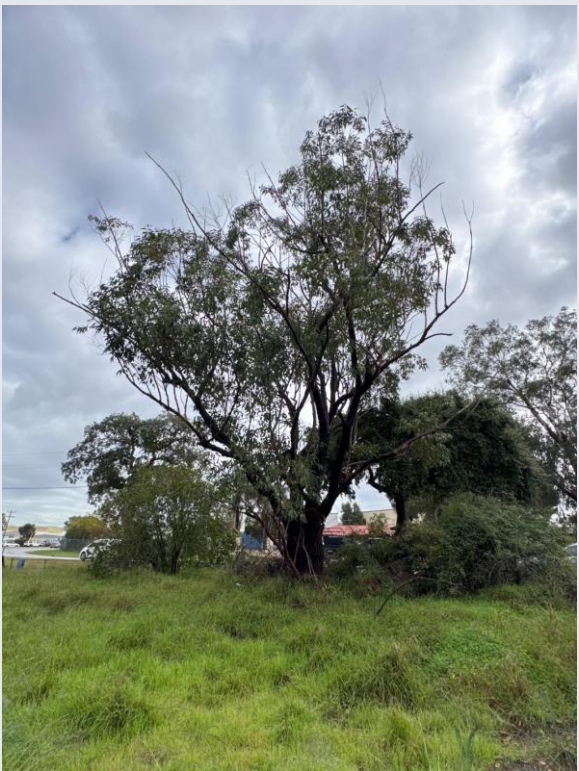
| Southern Mahogany Tree ID #10 | |

| Southern Mahogany Tree ID #10 | |
|---|---|
| Useful Life Expectancy: | 11-20 years |
| Retention Value: | Medium |

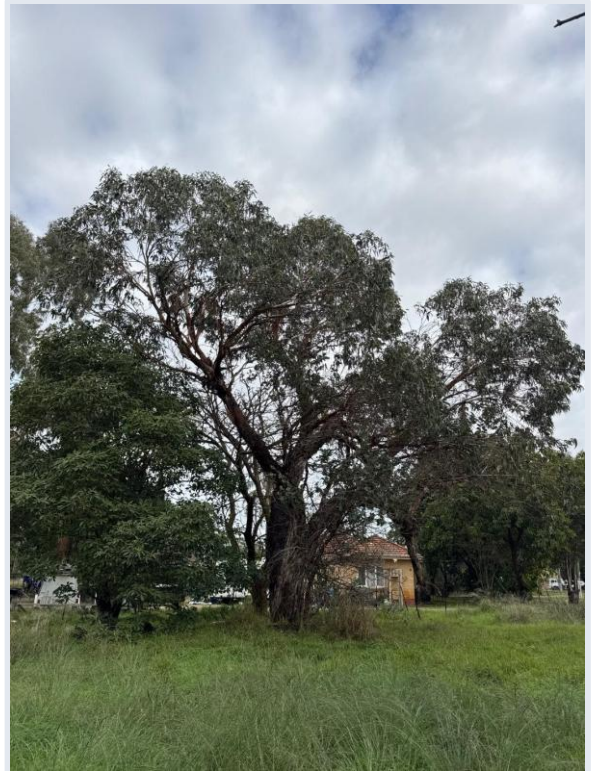
## Tasmanian Blue Gum Tree ID #11

| Retention Value: | Medium |

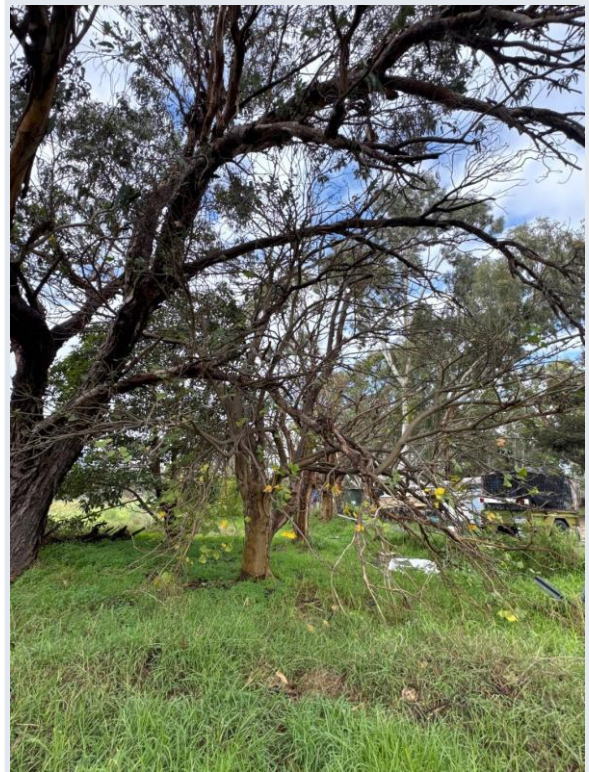
## Flame Tree ID #12

| Retention Value: | Low |

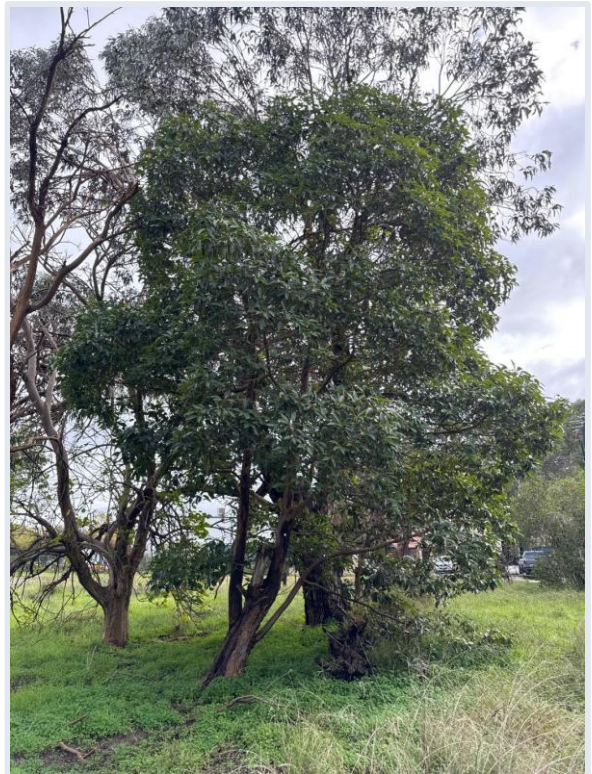
## Queensland Box Tree ID #13

| Retention Value: | Medium |

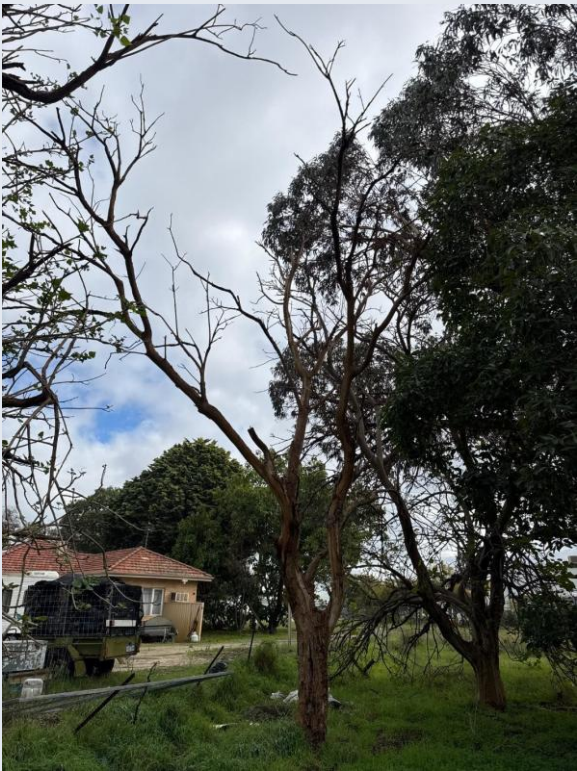
| Flame Tree ID #14 | |

| Flame Tree ID #14 | |
|---|---|
| Useful Life Expectancy: | 0 years |
| Retention Value: | Low |

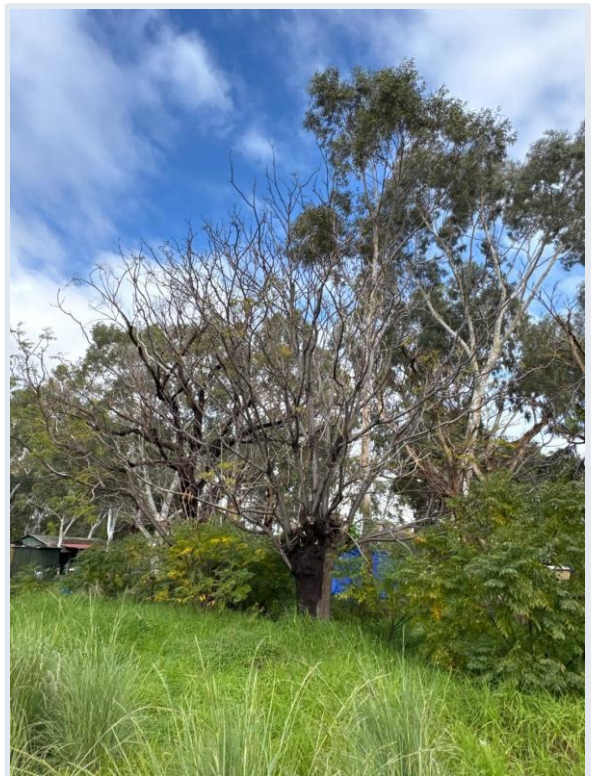
## Cape Lilac, White Cedar Tree ID #16

| Retention Value: | Low |

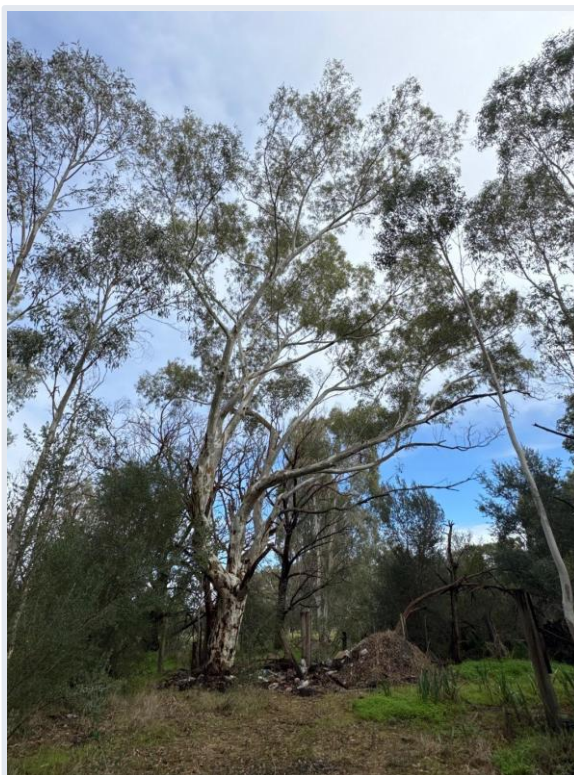
## River Red Gum Tree ID #31

| Tree Id | Latin Name | Tree Age | Tree Height [m] | Canopy Spread [m] | DSH [cm] | DRF [cm] | Health | Structure | Problems | Priority | Tree Work |
|---|---|---|---|---|---|---|---|---|---|---|---|
| 31 | <i>Eucalyptus camaldulensis</i> var. <i>camaldulensis</i> | Mature | 14 | 12 | 78 | 84 | Fair | Fair | Deadwood major >50, Deadwood minor <50, Epicormic growth, Included bark, Multi Crown leaders, Previous limb failure | Moderate | Remove major deadwood |

Problems: Multi Crown leaders,  
Deadwood major >50,  
Deadwood minor <50,  
Epicormic growth,  
Included bark,  
Previous limb failure

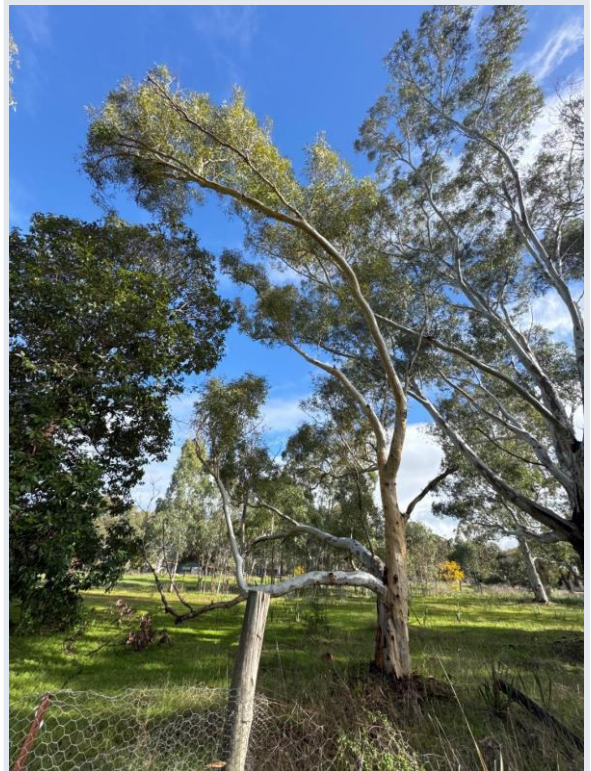
## River Red Gum Tree ID #34

| Tree Id | Latin Name | Tree Age | Tree Height [m] | Canopy Spread [m] | DSH [cm] | DRF [cm] | Health | Structure | Problems | Priority | Tree Work |
|---|---|---|---|---|---|---|---|---|---|---|---|
| 34 | <i>Eucalyptus camaldulensis</i> var. <i>camaldulensis</i> | Mature | 10 | 8.2 | 55.88 | 52 | Fair | Poor | Deadwood major >50, Deadwood minor <50, Excessive Limb Loading, Extended branches, Multi Crown leaders, Phototropism, Previous limb failure | Low | Remove major deadwood |

| Problems: | Phototropism,<br>Deadwood major >50,<br>Extended branches,<br>Deadwood minor <50,<br>Previous limb failure,<br>Excessive Limb<br>Loading, Multi Crown<br>leaders |

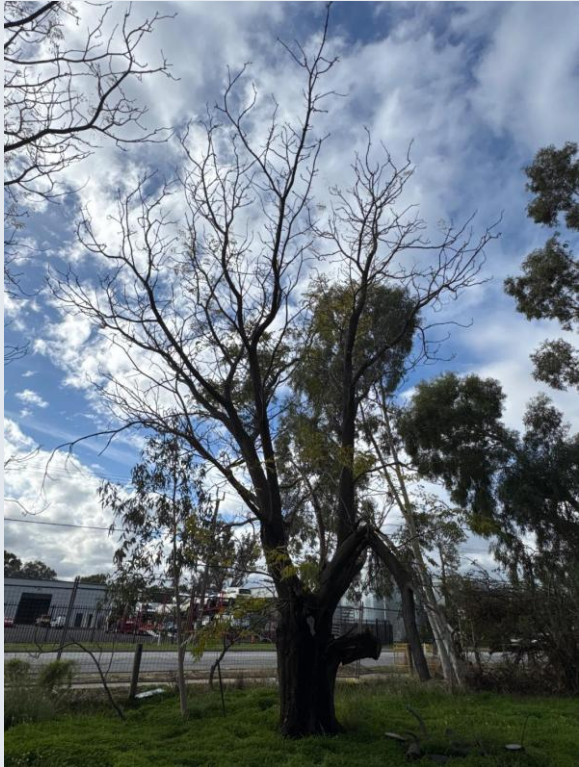
| Tree Id | Latin Name | Tree Age | Tree Height [m] | Canopy Spread [m] | DSH [cm] | DRF [cm] | Health | Structure | Problems | Priority | Tree Work |
|---|---|---|---|---|---|---|---|---|---|---|---|
| 46 | <i>Melia azedarach</i> | Mature | 9 | 9 | 92 | 87 | Fair | Fair | Broken branch, Deadwood major >50, Deadwood minor <50, Multi Crown leaders, Previous limb failure | Low | Remove major deadwood |

| Cape Lilac, White Cedar Tree ID #46 | | | |
|---|---|---|---|
| Problems: | Broken branch,<br>Deadwood major >50,<br>Deadwood minor <50,<br>Previous limb failure,<br>Multi Crown leaders | | |

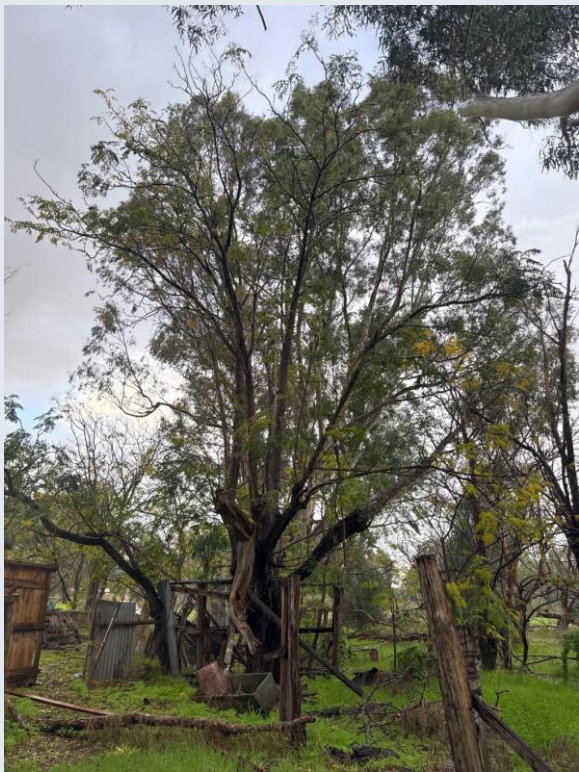
| Cape Lilac, White Cedar Tree ID #65 | | | |

| Cape Lilac, White Cedar Tree ID #65 | | | |
|---|---|---|---|
| Problems: | Canopy thinning evident. Deadwood minor <50. Previous limb failure. Multi Crown leaders | | |

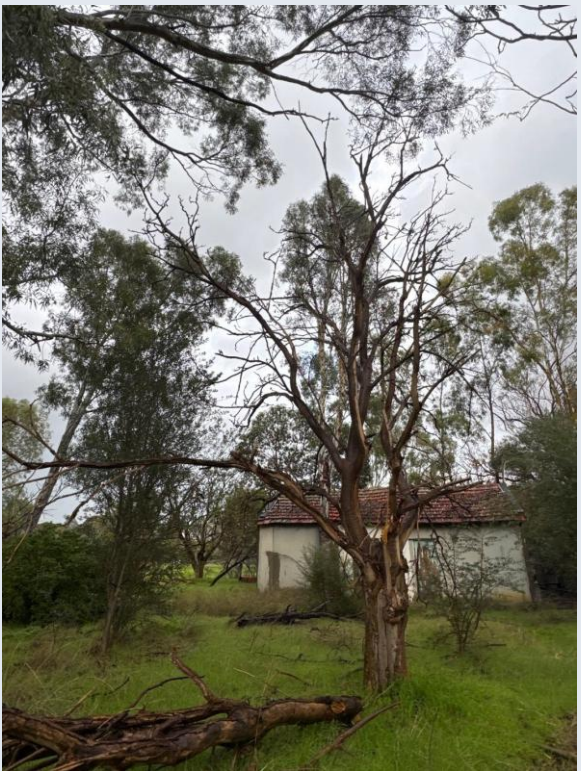
| Tree Id | Latin Name | Tree Age | Tree Height [m] | Canopy Spread [m] | DSH [cm] | DRF [cm] | Health | Structure | Problems | Priority | Tree Work |
|---|---|---|---|---|---|---|---|---|---|---|---|
| 67 | <i>Melia azedarach</i> | Mature | 6.7 | 4 | 56.36 | 54 | Very Poor | Fair | Bark wound, Deadwood major >50, Deadwood minor <50, Decline, Epicormic growth, Multi Crown leaders, Previous limb failure, Trunk Decay | Moderate | Remove Tree |

| Cape Lilac, White Cedar Tree ID #67 | |
|---|---|
| Problems: | Deadwood minor <50, Deadwood major >50, Epicormic growth, Trunk Decay, Previous limb failure, Bark wound, Multi Crown leaders, Decline |

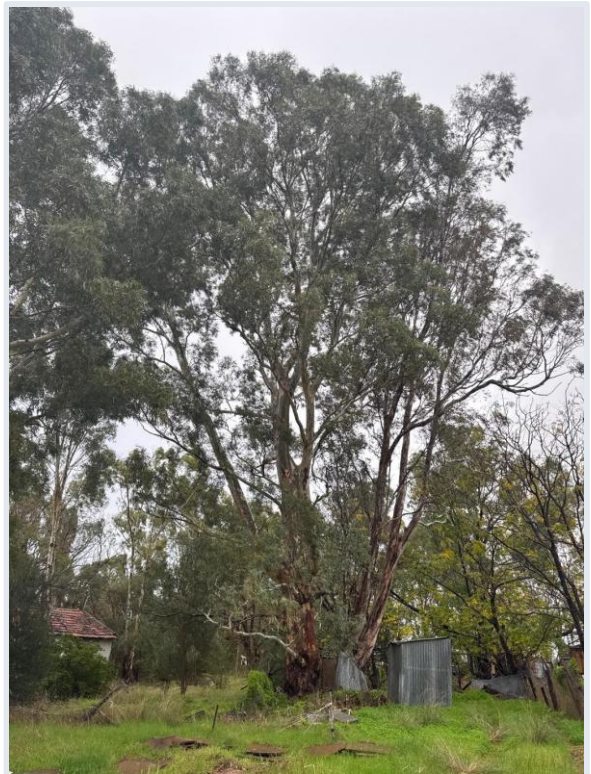
## River Red Gum Tree ID #68

| Problems: | Deadwood minor <50,<br>Epicormic growth,<br>Included bark,<br>Previous limb failure,<br>Active Termites,<br>Codominant Stem |

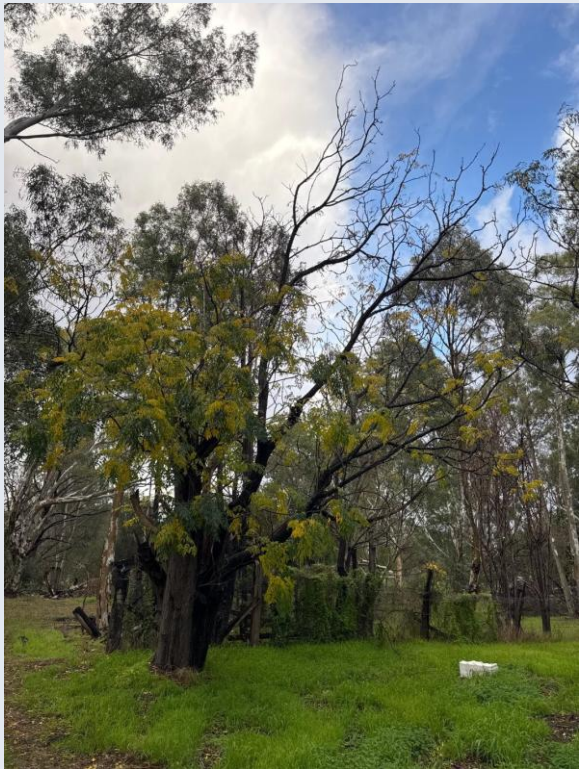
| Cape Lilac, White Cedar Tree ID #71 | |

| Cape Lilac, White Cedar Tree ID #71 | |
|---|---|
| Problems: | Deadwood minor <50, Canopy thinning evident, Multi Crown leaders, Previous limb failure, Epicormic growth, Deadwood major >50 |

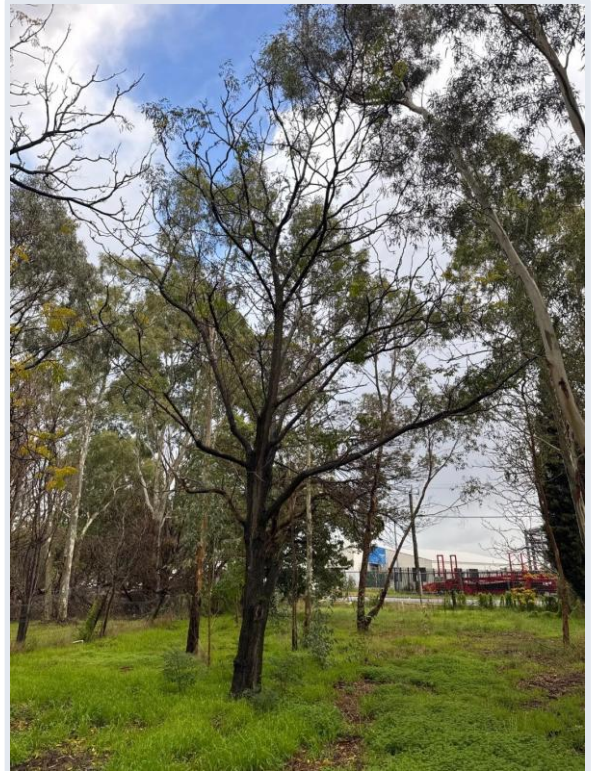
## Cape Lilac, White Cedar Tree ID #72

| Problems: | Deadwood minor <50,<br>Previous limb failure,<br>Bark wound, Twin<br>Stem, Epicormic<br>growth |

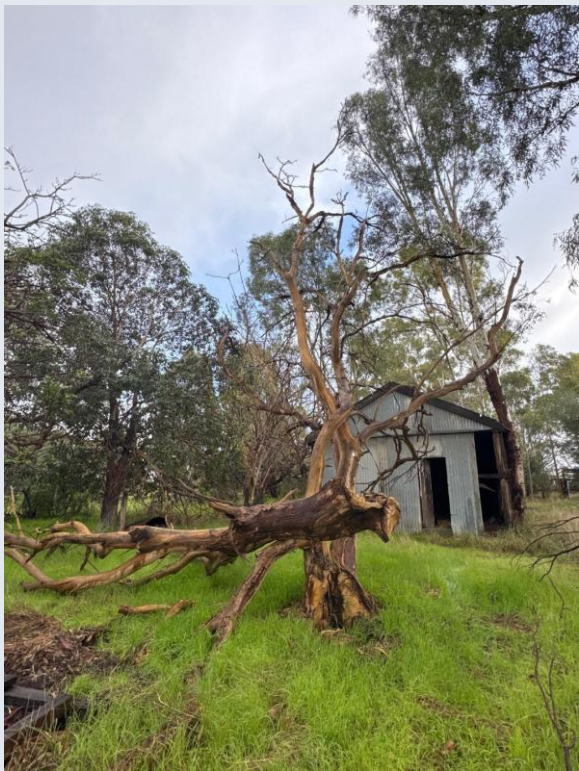
| Flame Tree ID #74 | |

| Tree Id | Latin Name | Tree Age | Tree Height [m] | Canopy Spread [m] | DSH [cm] | DRF [cm] | Health | Structure | Problems | Priority | Tree Work |
|---|---|---|---|---|---|---|---|---|---|---|---|
| 74 | <i>Erythrina sykesii</i> | Mature | 6 | 5.2 | 37 | 50 | Dead | Very poor | Bark wound, Basal decay, Deadwood major >50, Deadwood minor <50, Leaning, Previous limb failure | Moderate | Remove Tree |

| Flame Tree ID #74 | |
|---|---|
| Problems: | Basal decay, Bark wound, Previous limb failure, Leaning, Deadwood minor <50, Deadwood major >50 |

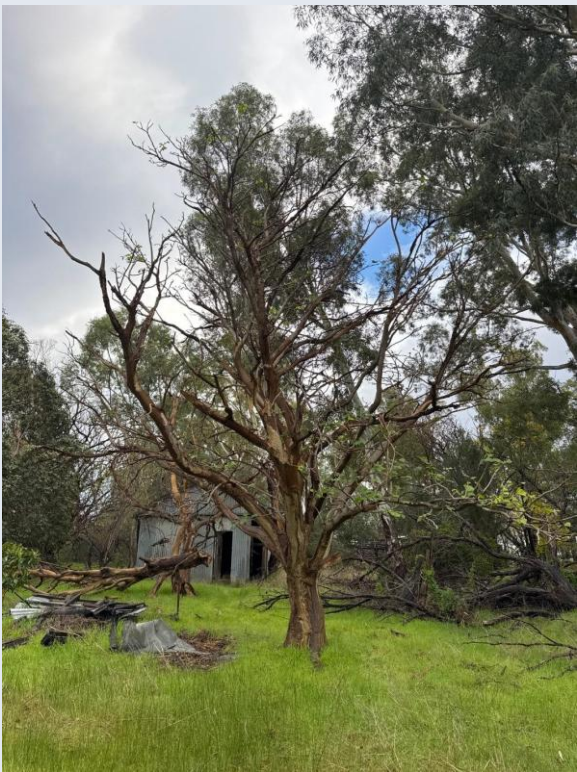
| Flame Tree ID #76 | |

| Tree Id | Latin Name | Tree Age | Tree Height [m] | Canopy Spread [m] | DSH [cm] | DRF [cm] | Health | Structure | Problems | Priority | Tree Work |
|---|---|---|---|---|---|---|---|---|---|---|---|
| 76 | <i>Erythrina sykesii</i> | Mature | 6 | 7 | 59.82 | 73 | Poor | Fair | Bark wound, Deadwood major >50, Deadwood minor <50, Multi Crown leaders, Previous limb failure, Trunk Decay | Low | Remove Tree |

| Flame Tree ID #76 | |
|---|---|
| Problems: | Bark wound, Previous limb failure, Trunk Decay, Deadwood minor <50, Deadwood major >50, Multi Crown leaders |

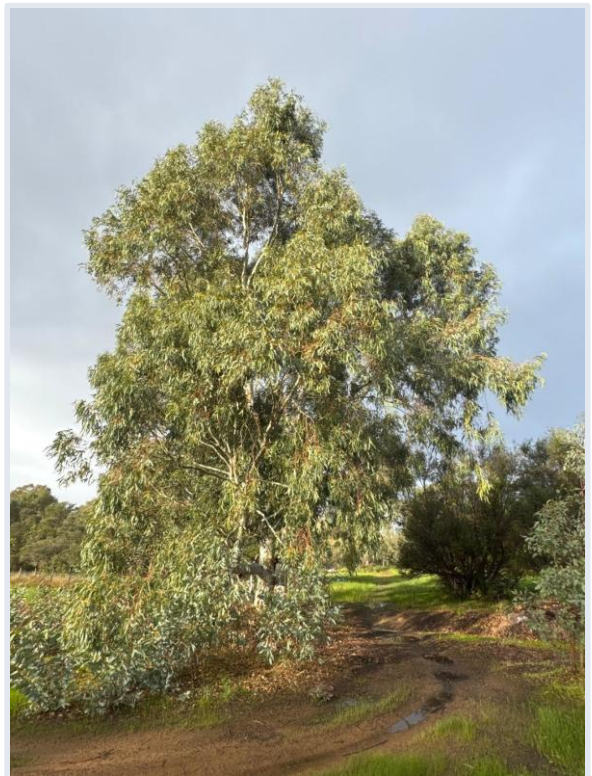
## River Red Gum Tree ID #78

| Problems: | Compression Fork,<br>Previous limb failure,<br>Codominant Stem |
